One annoying problem with the Featherweight is the clicking sound that sometimes occurs when sewing. If the noise comes from the bobbin area of the machine, and you have already confirmed that the needle is installed correctly – flat goes to the left and the feed dogs are not hitting the needle plate, another likely place to look is the Rotating Hook Bobbin Case Position Plate Springs. I know, that is a really long name for a small part but this is the name given by Singer. Basically on the bottom of the needle plate is another plate held on by two screws, which holds two flat springs. These springs, over time, can become compressed and lose the tension that they originally had against the Bobbin Case Base positioning finger. These springs act to dampen the movement of the Bobbin Case Base and still allow the thread to pass through. If the springs have lost their tension, there will be an audible clicking sound when the Bobbin Case Base positioning finger is able to move too far and hits the spring instead of being gently held by the spring.

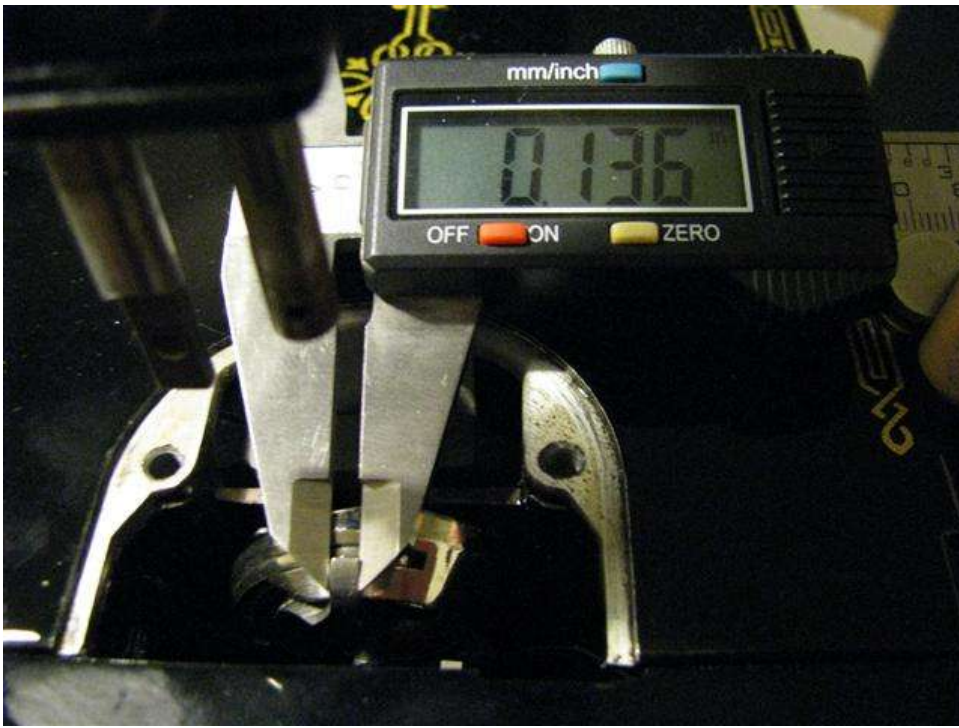
Bobbin Case positioning finger between Bobbin Case Position Plate Springs

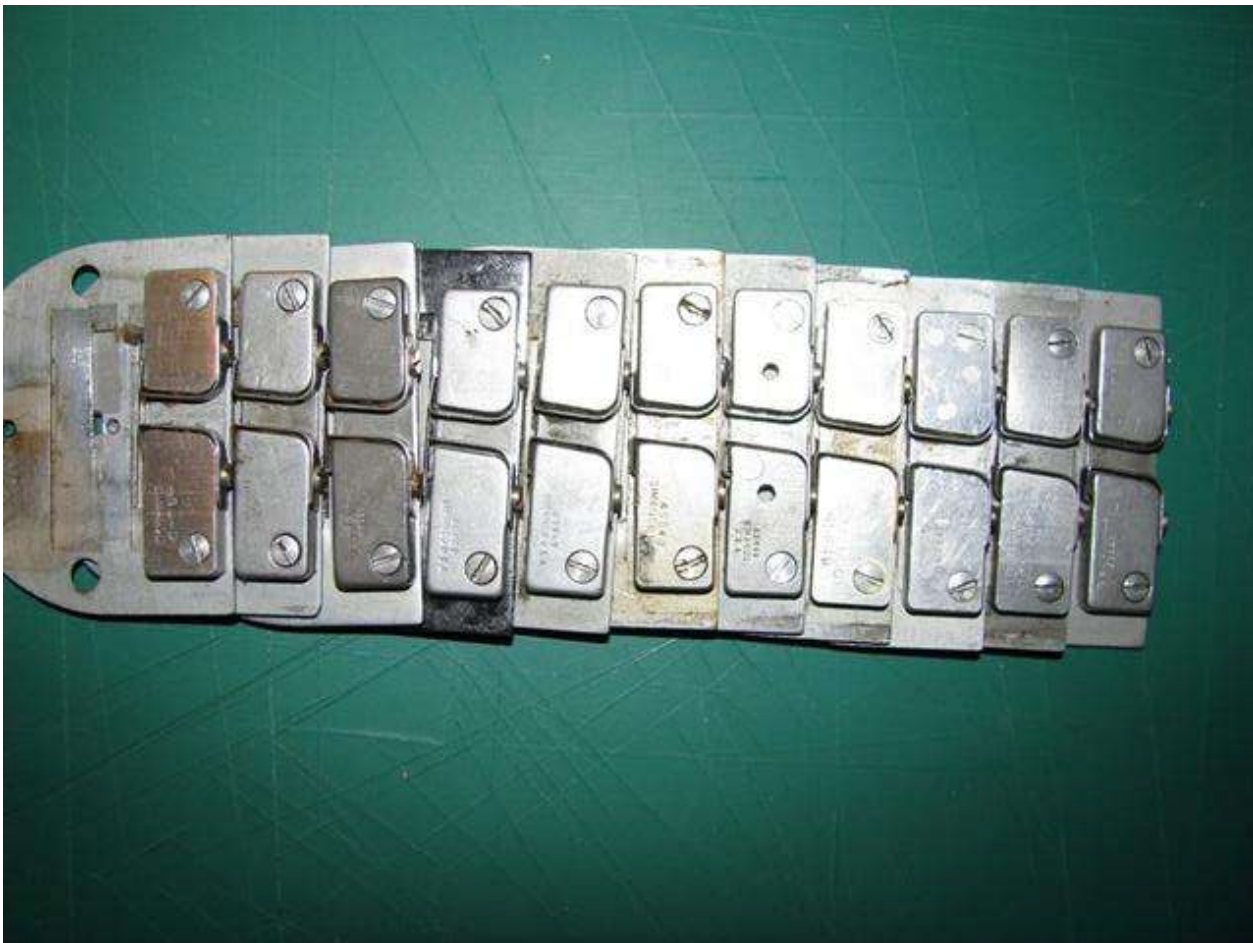
I then took 12 used needle plates from my stock and measured the distance between the springs and found the gap ranges from 0.138 to 0.167 inches, with an average of 0.152 inches. While the difference between the largest gap of 0.167 and the width of the positioning finger is only 0.03 inches, it is significant enough to

cause the noise. To confirm, I installed this plate on a known good machine and sure enough, it clicked.

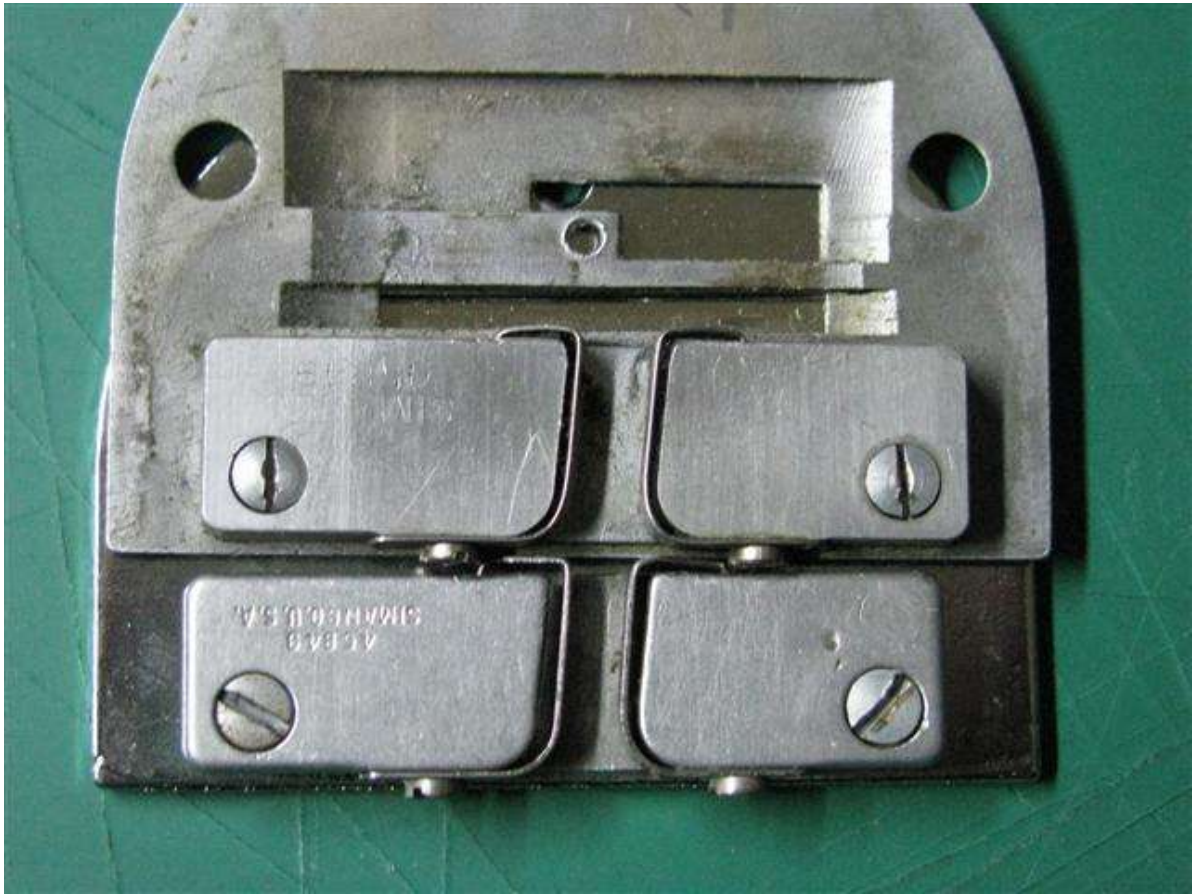
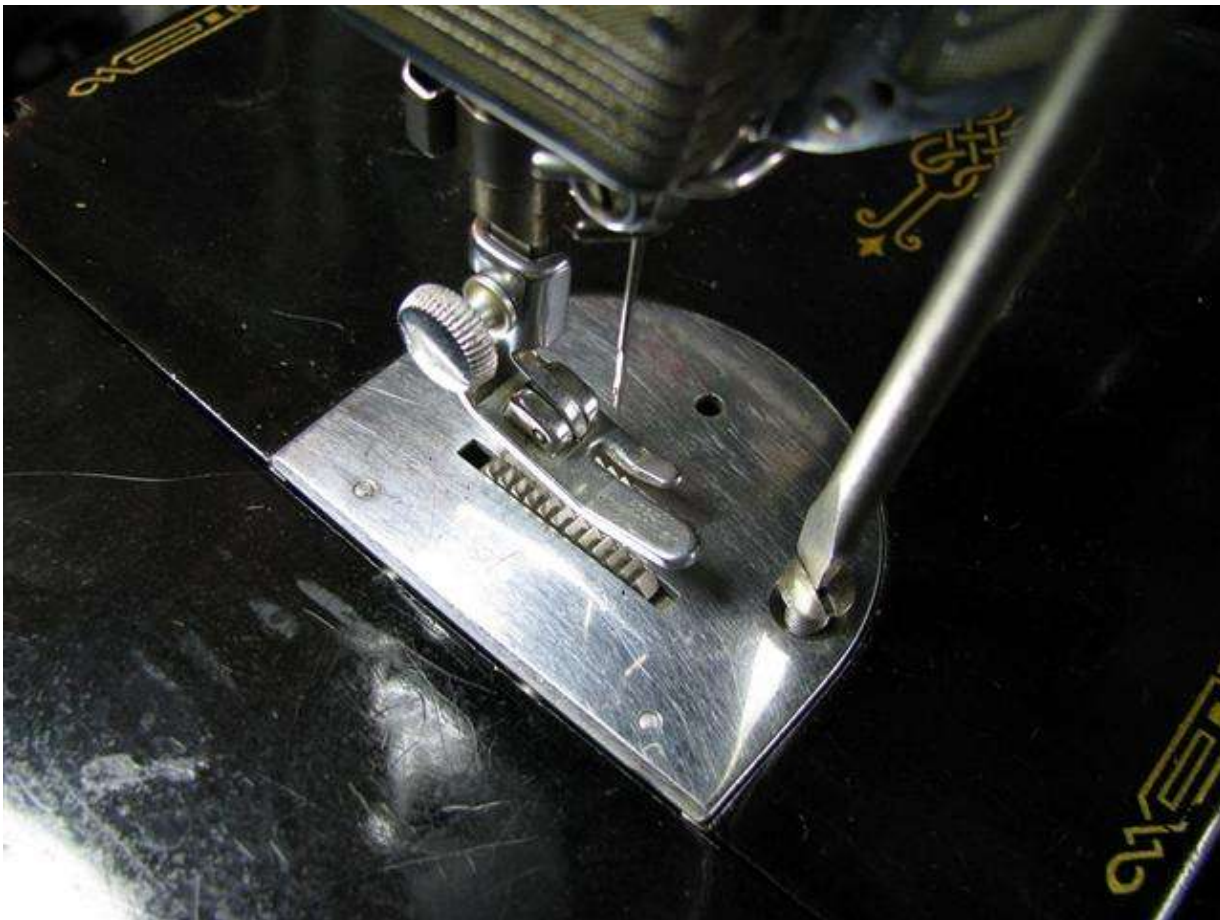
Notice the difference in the gap between the springs of these two plates

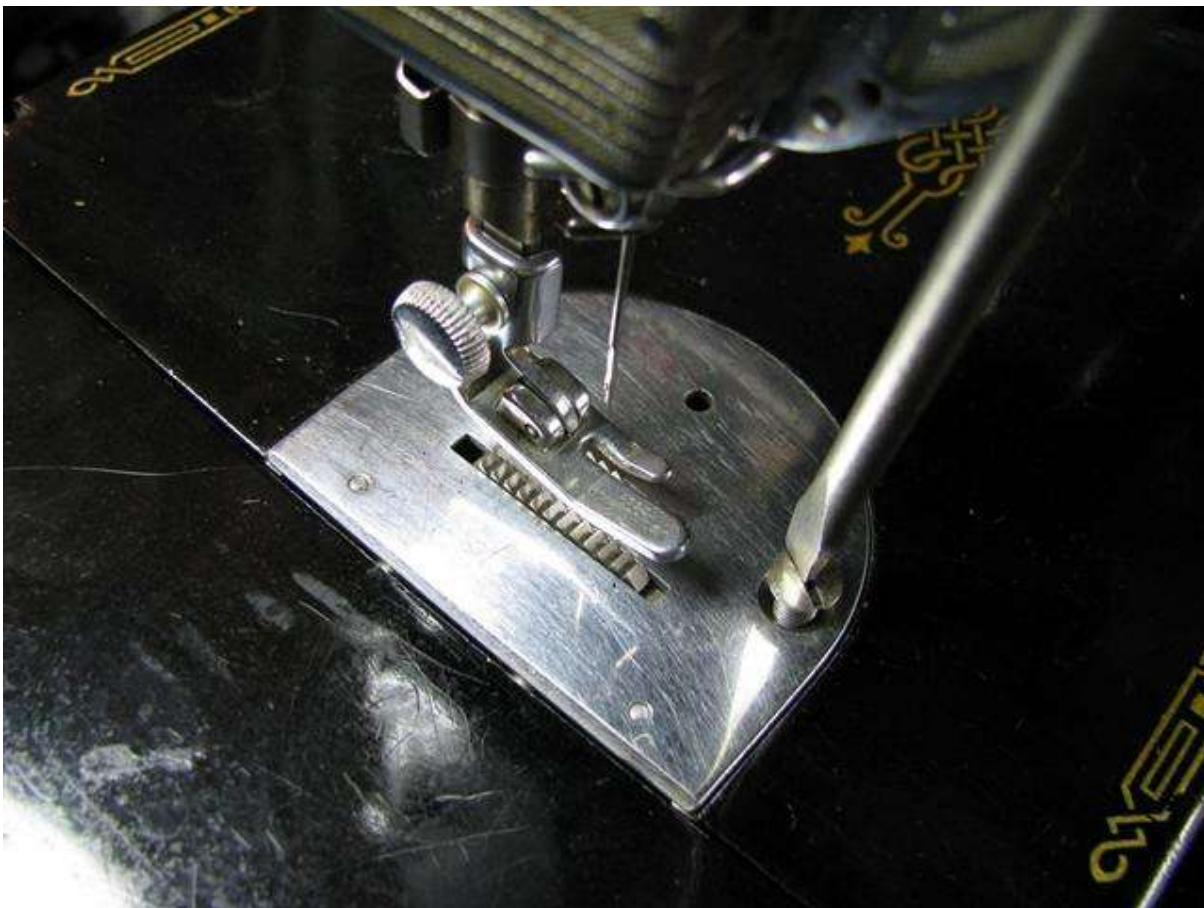
This should help eliminate the clicking noise. To test I reinstalled the repaired plate on my known good machine and the clicking noise was gone.

Then replace the needle plate, aligning the Bobbin Case positioning finger between the springs and replace the needle plate screws.
